ALERT SERVICE BULLETIN

Checking of the cylinder head assy. 2/3 for ROTAX® Engine Type 912 and 914 (Series)

ATA System: 72-30-00 Cylinder head

MANDATORY

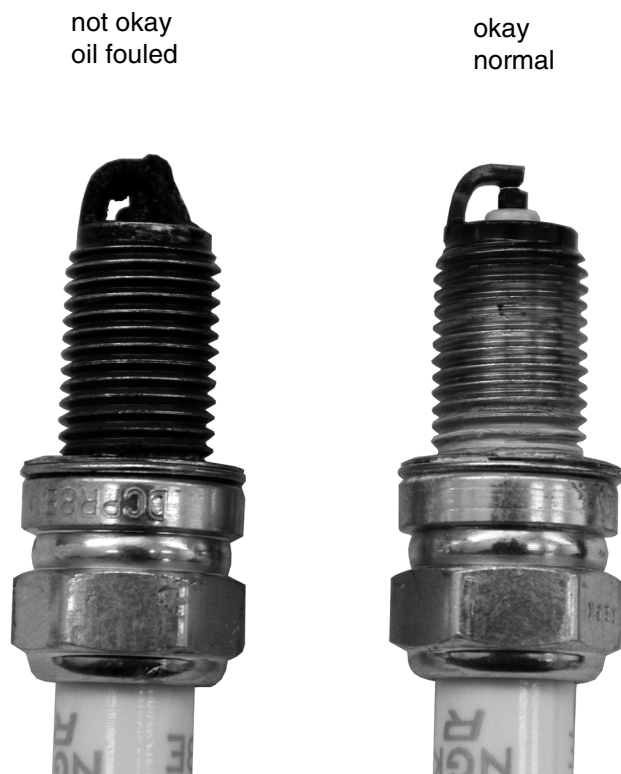
*Fig. 1
spark plug*

NOTE: Unusual deposits (excessive carbon or oil) on the spark plugs are an indication of a defective cylinder head which must be replaced. Figure 1 shows comparison between a used spark plug in normal condition and one that is not.

Affected spark plugs with such deposits shown in chapter 4 Fig. 1, have to be removed and can not be reinstalled.

If excessive deposits (oil or carbon) are found on one of the spark plugs the cylinder head must be replaced in accordance with the relevant Maintenance Manual (Heavy) and any relevant aircraft manufacturer instructions.
