SERVICE LETTER
NON-APPROVED MODIFICATIONS OR
USE OF ROTAX® UNAPPROVED ENGINE
COMPONENTS OR ACCESSORIES
FOR ROTAX® AIRCRAFT ENGINES
SL-912-014 R3
SL-914-012 R3
SL-2ST-008 R3

3.1.1) Example of a “repaired” crankshaft

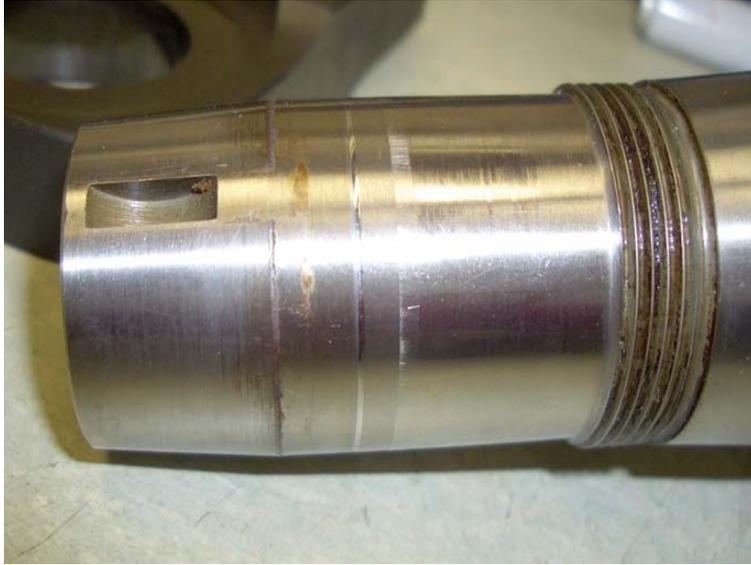
fig. 1

- The crankshaft has a ROTAX[®] part no. 888164 and a serial number (S/N) of S/N 11798, but was not marked as overhauled and shows some serious deficiencies:
 - signs of corrosion in the area of the oil seal (see fig. 1)
 - crankshaft was beyond the out of round limit
 - torque at twist test was below limit
 - a conrod bearing shows signs of wear (see fig. 2)
 - contamination in the oil channels (see fig. 3)

Such a crankshaft is not airworthy and should not be installed or any parts reused according to ROTAX[®]-instructions.

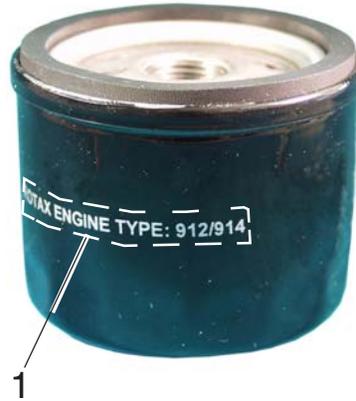
fig. 4

- The oil filter infringes on copyright/without permission ROTAX[®] a ROTAX ENGINE Type 912/914 label (1) and has some serious technical deficiencies:
 - no by-pass valve (2) = in case of contamination this can lead to a completely blocked oil system
 - filter insert (3): shorter than the genuine = less filter surface and reduced dirt pick-up
 - no genuine ROTAX[®] part number
 - sharp-edged inner spring (4) = this can cause wear and cracks in the filter housing
 - no return-valve (5) = after switching-off the engine self-draining of the oil filter will not be avoided. When the engine is started again it will require a longer time (less film lubrication) until the necessary operating pressure is reached.

non-genuine ROTAX® oil filter

- 1 label
- 2 by-pass valve
- 3 filter insert
- 4 spring
- 5 no return valve installed

Such an oil filter is not airworthy and should not be installed or be further used according to ROTAX[®]-instructions.

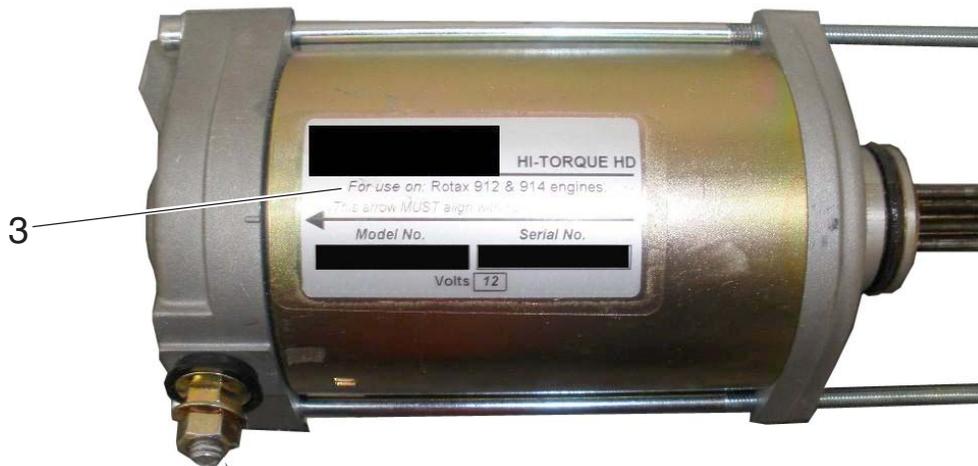
fig. 7

- The electric starter uses a ROTAX[®] 912/914 engine label (1) without permission from ROTAX[®] and has some serious technical deficiencies:
 - no oil seal (1) in support (2)
 - ▲**WARNING:** This can cause oil return issues into the oil tank due to loss of crankcase pressure.
 - no genuine ROTAX[®] part number (4)
 - no standard serial number (4), which is signed on essential components for traceability at ROTAX[®]

non-genuine ROTAX® electric starter

- 1 oil seal
- 2 support
- 3 label
- 4 ROTAX® part number and serial number

Such an electric starter is not airworthy and should not be installed or be further used according to ROTAX[®]-instructions.
